**CLEAN WATER ACT COMPLIANCE INSPECTION
U.S. ENVIRONMENTAL PROTECTION AGENCY, REGION 5**

Legend Farms Dairy, LLC

Date of Inspection: April 20, 2017 - April 21, 2017

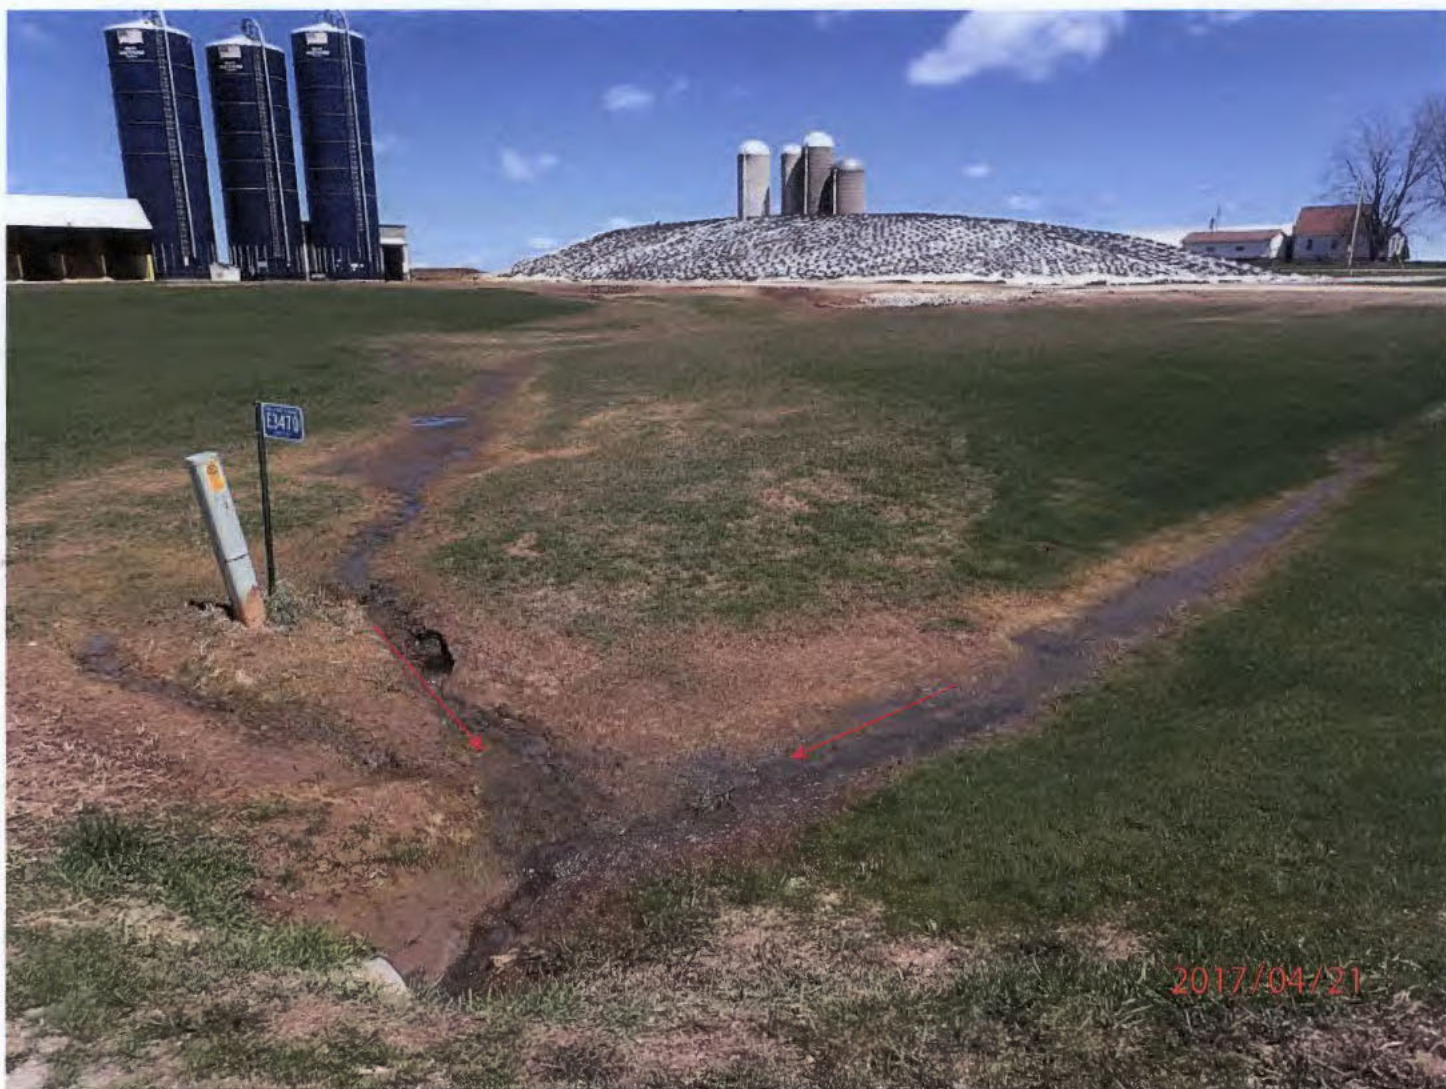
Photo: P4210093

Description: EPA observed the process wastewater discharging off of the west side of the silage pad and converging with the process wastewater flowing in the roadside ditch on the north side of County Road F flowing through the culvert under the 2nd driveway west of Lilac Lane.

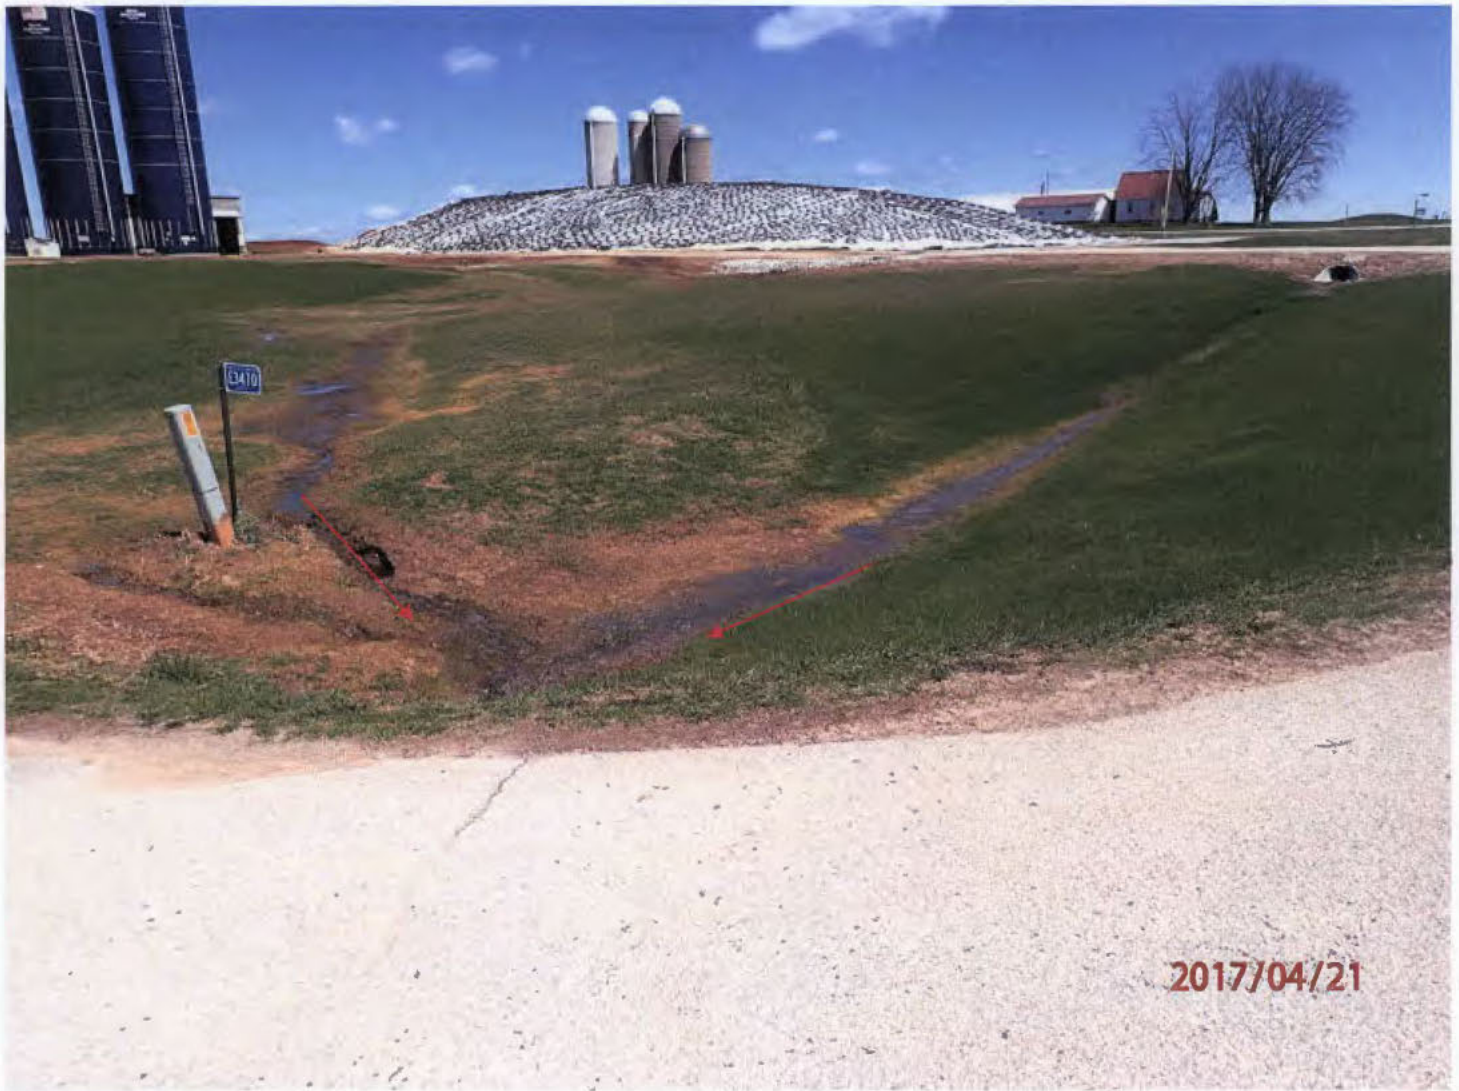
Photo: P4210094

Description: EPA observed the process wastewater discharging off of the west side of the silage pad and converging with the process wastewater flowing in the roadside ditch on the north side of County Road F flowing through the culvert under the 2nd driveway west of Lilac Lane.

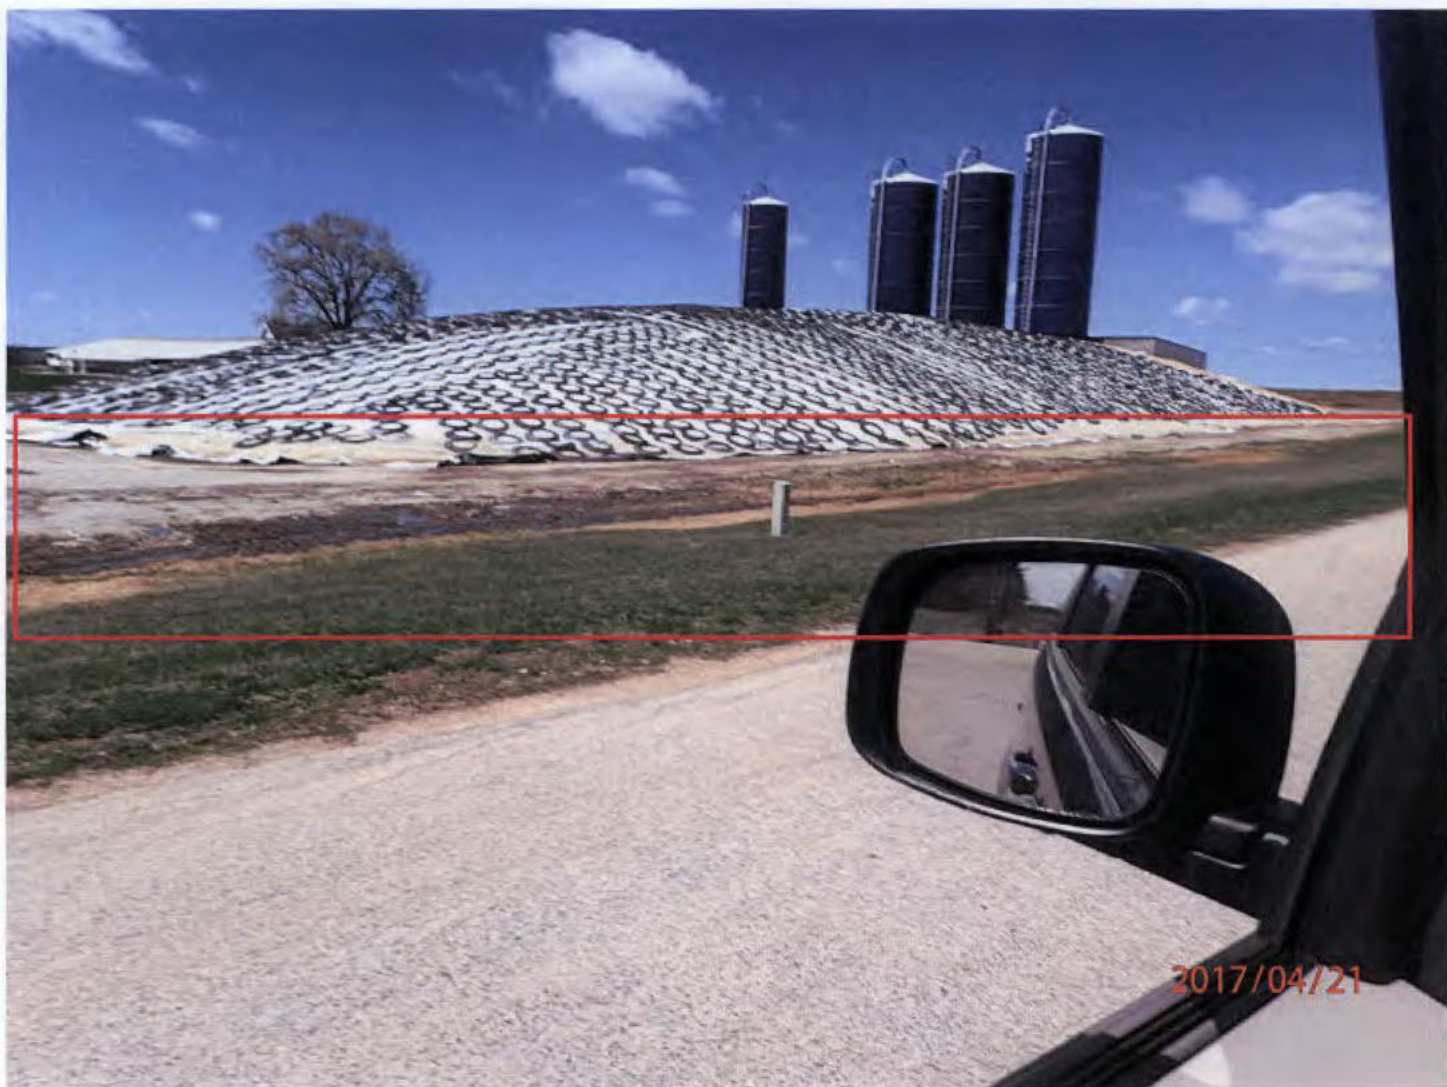
Photo: P4210095

Description: EPA observed feed and surface water discharging off of the east side of the silage pad into the roadside ditch west of Lilac Lane. Red outline is showing the feed and surface water on the silage pad and in the roadside ditch.

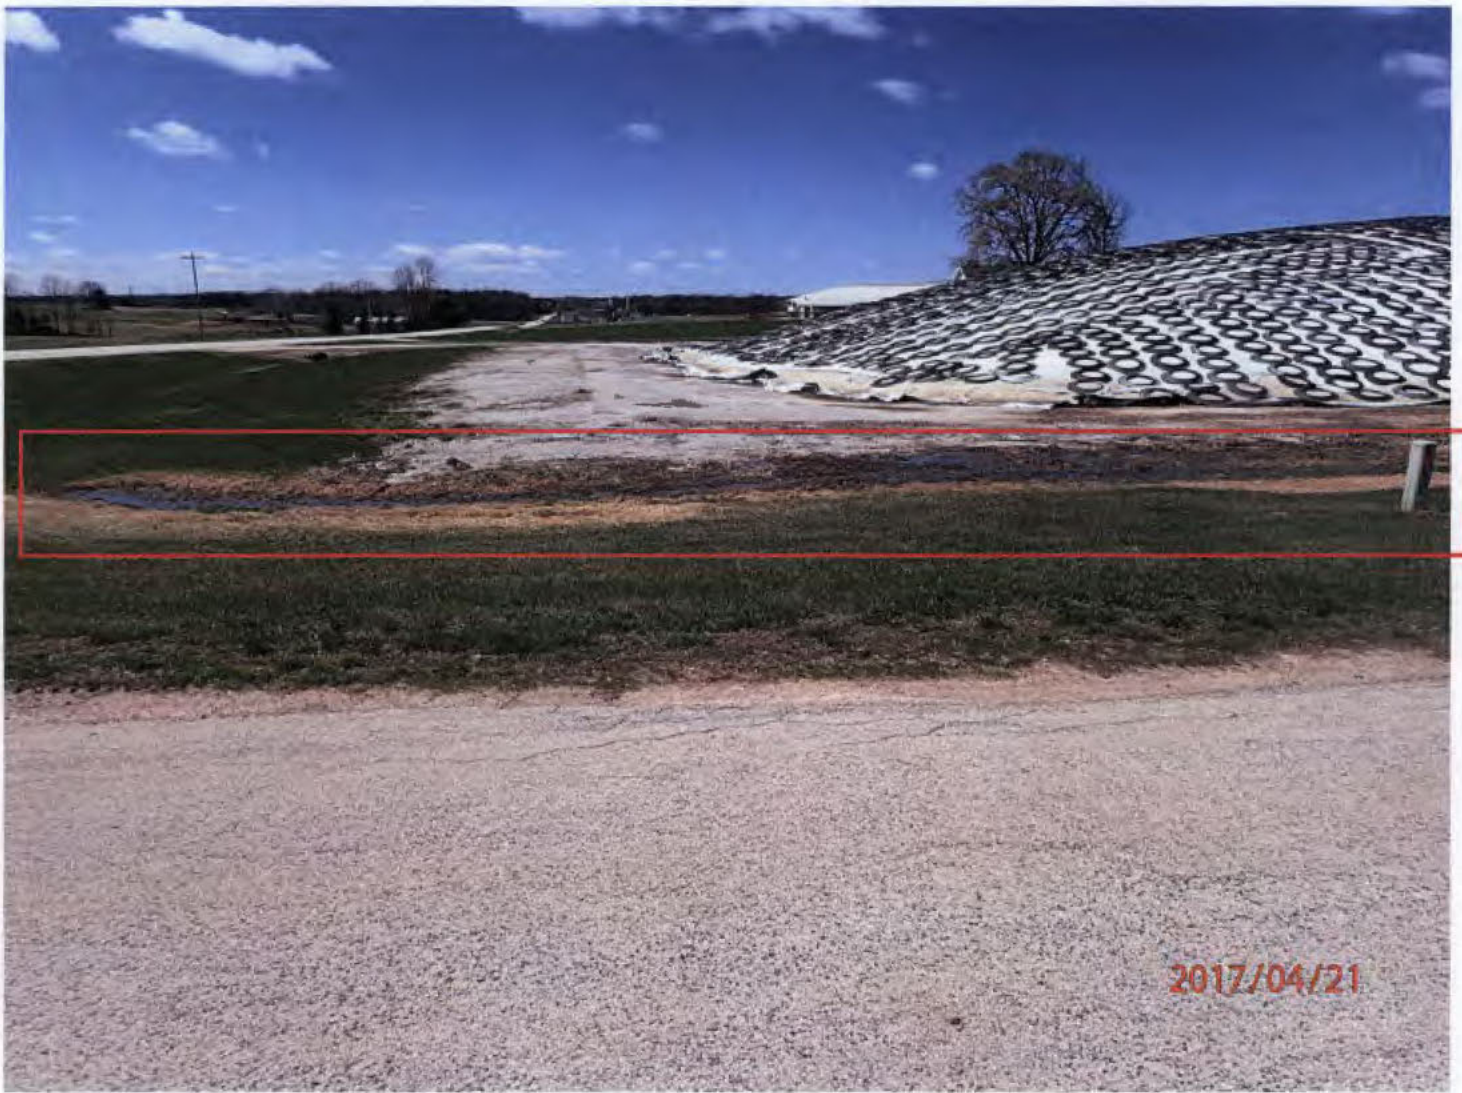
Photo: P4210096

Description: EPA observed feed and surface water discharging off of the east side of the silage pad into the roadside ditch west of Lilac Lane.

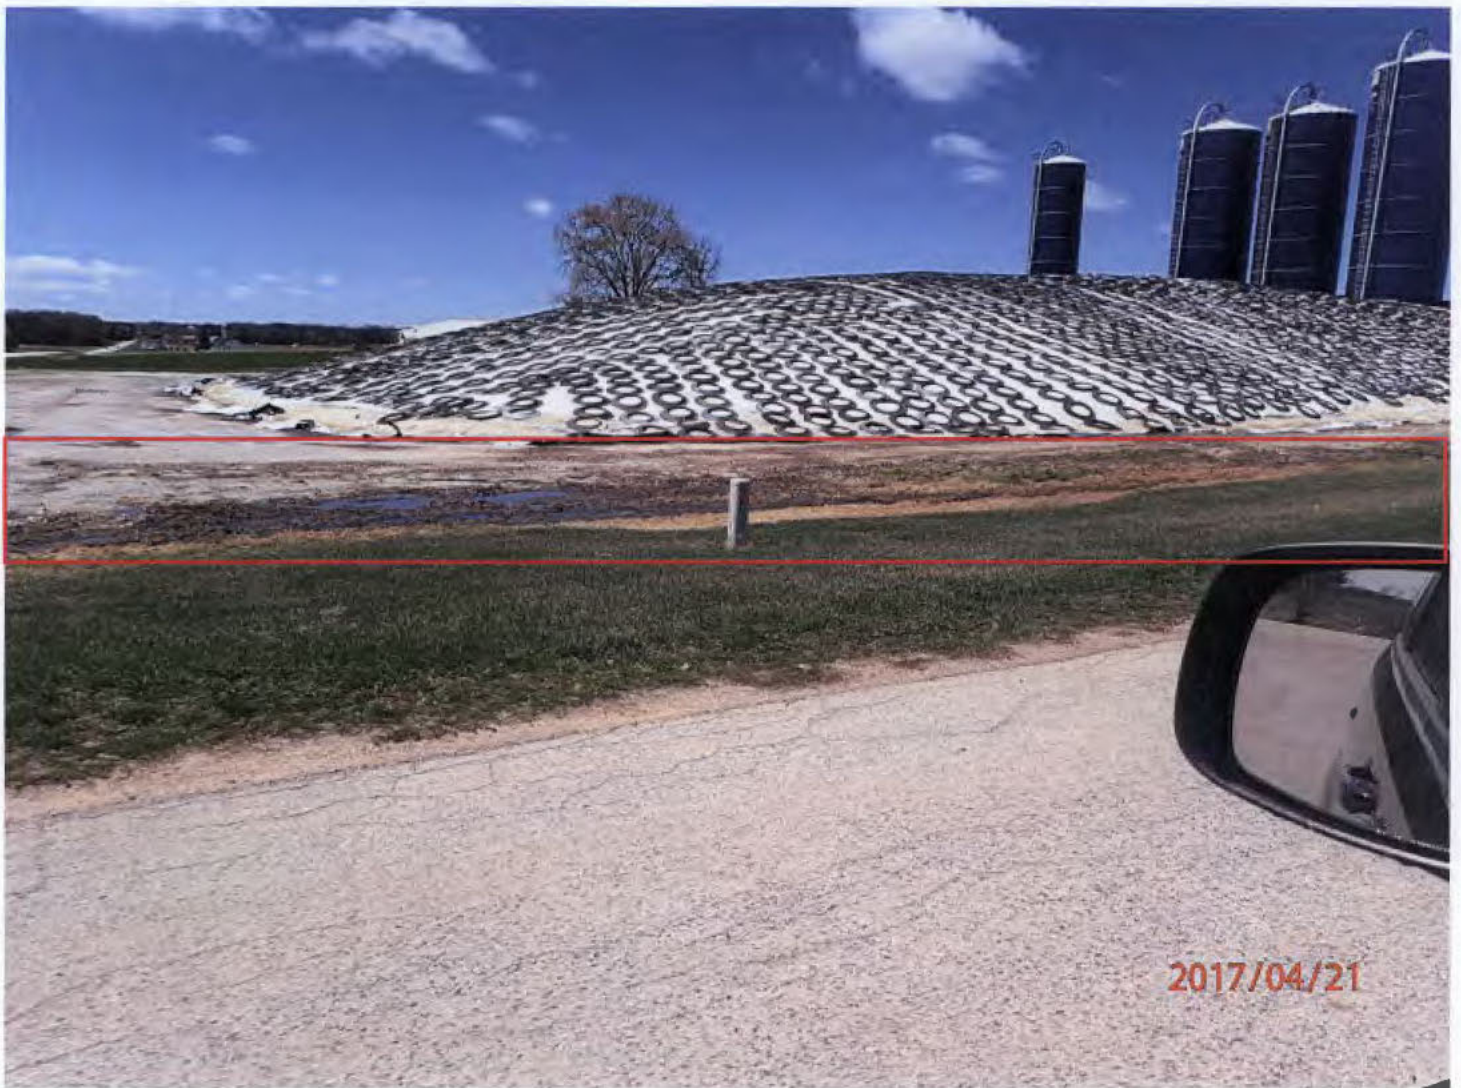
Photo: P4210097

Description: EPA observed feed and surface water discharging off of the east side of the silage pad into the roadside ditch west side of Lilac Lane.

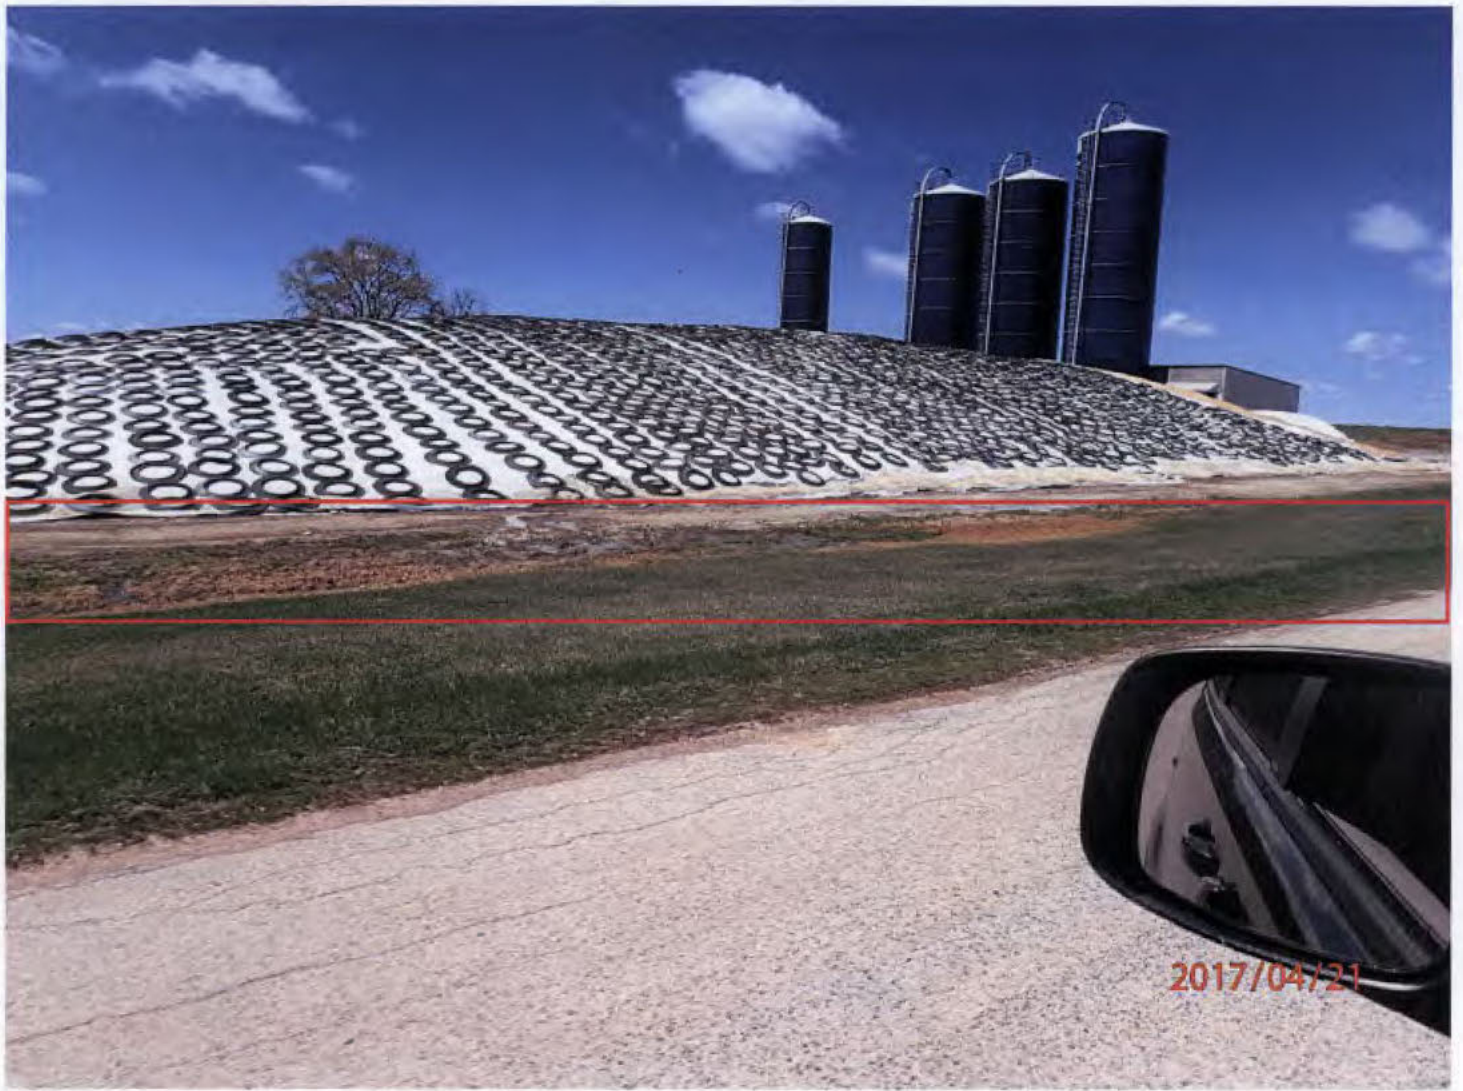
Photo: P4210098

Description: EPA observed feed and surface water discharging off of the east side of the silage pad into roadside ditch west of Lilac Lane.

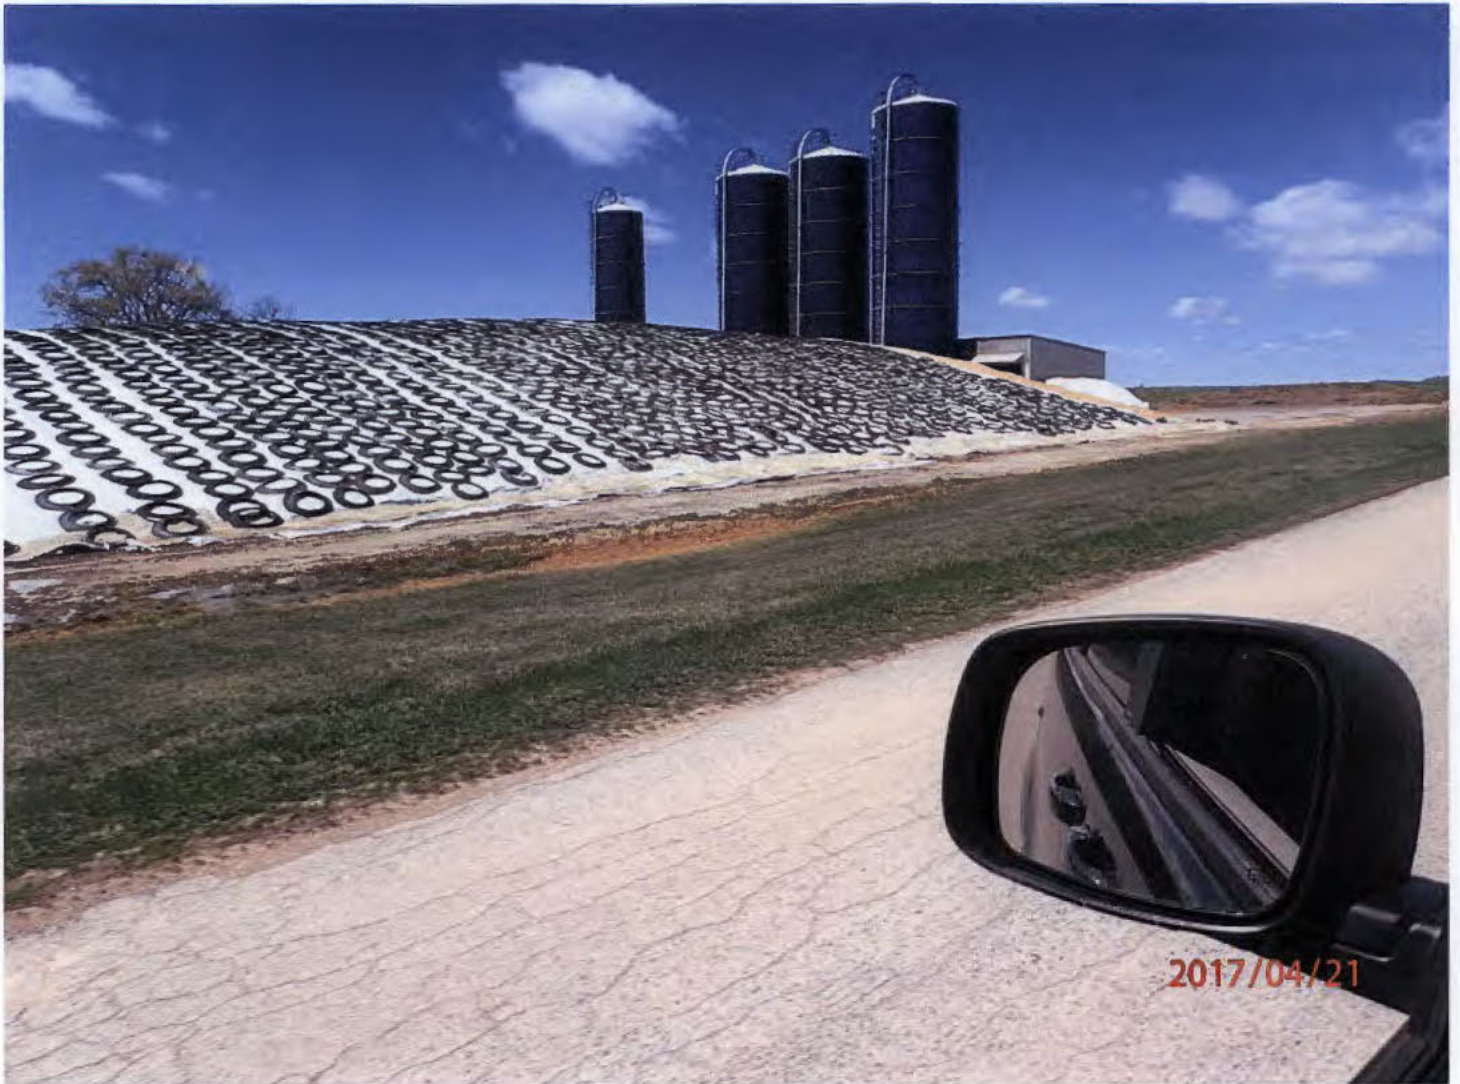
Photo: P4210099

Description: EPA observed feed and surface water on the east side of the silage pad discharging into the roadside ditch on the west side of Lilac Lane.

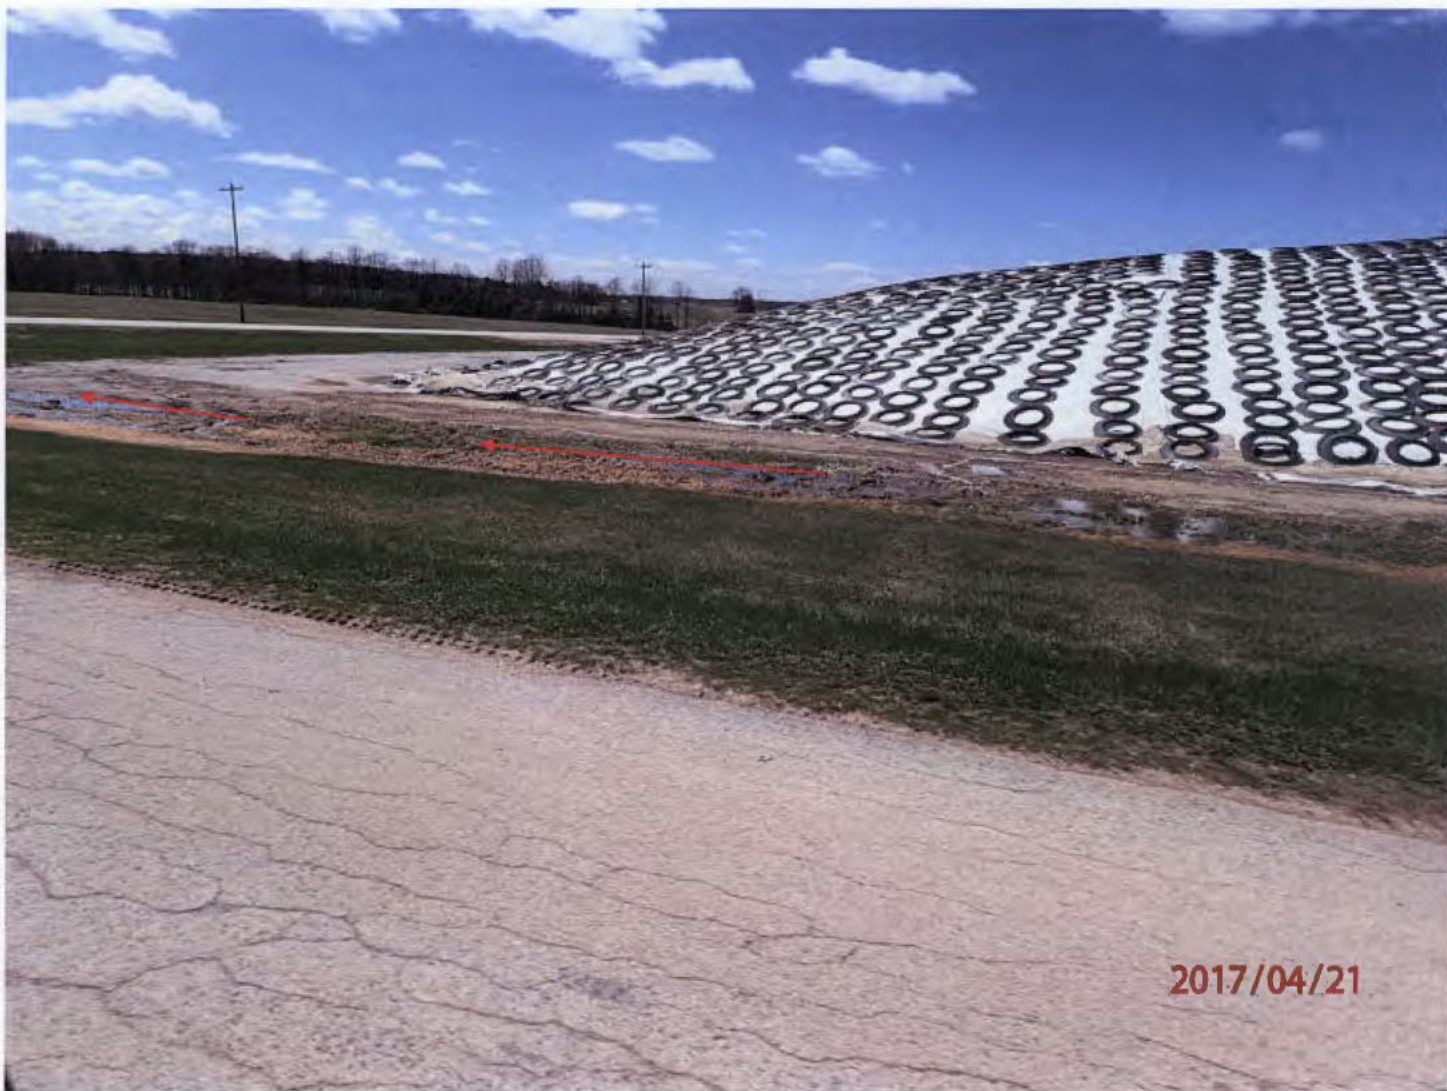
Photo: P4210100

Description: EPA observed feed and surface water on the east side of the silage pad discharging into the roadside ditch on the west side of Lilac Lane.

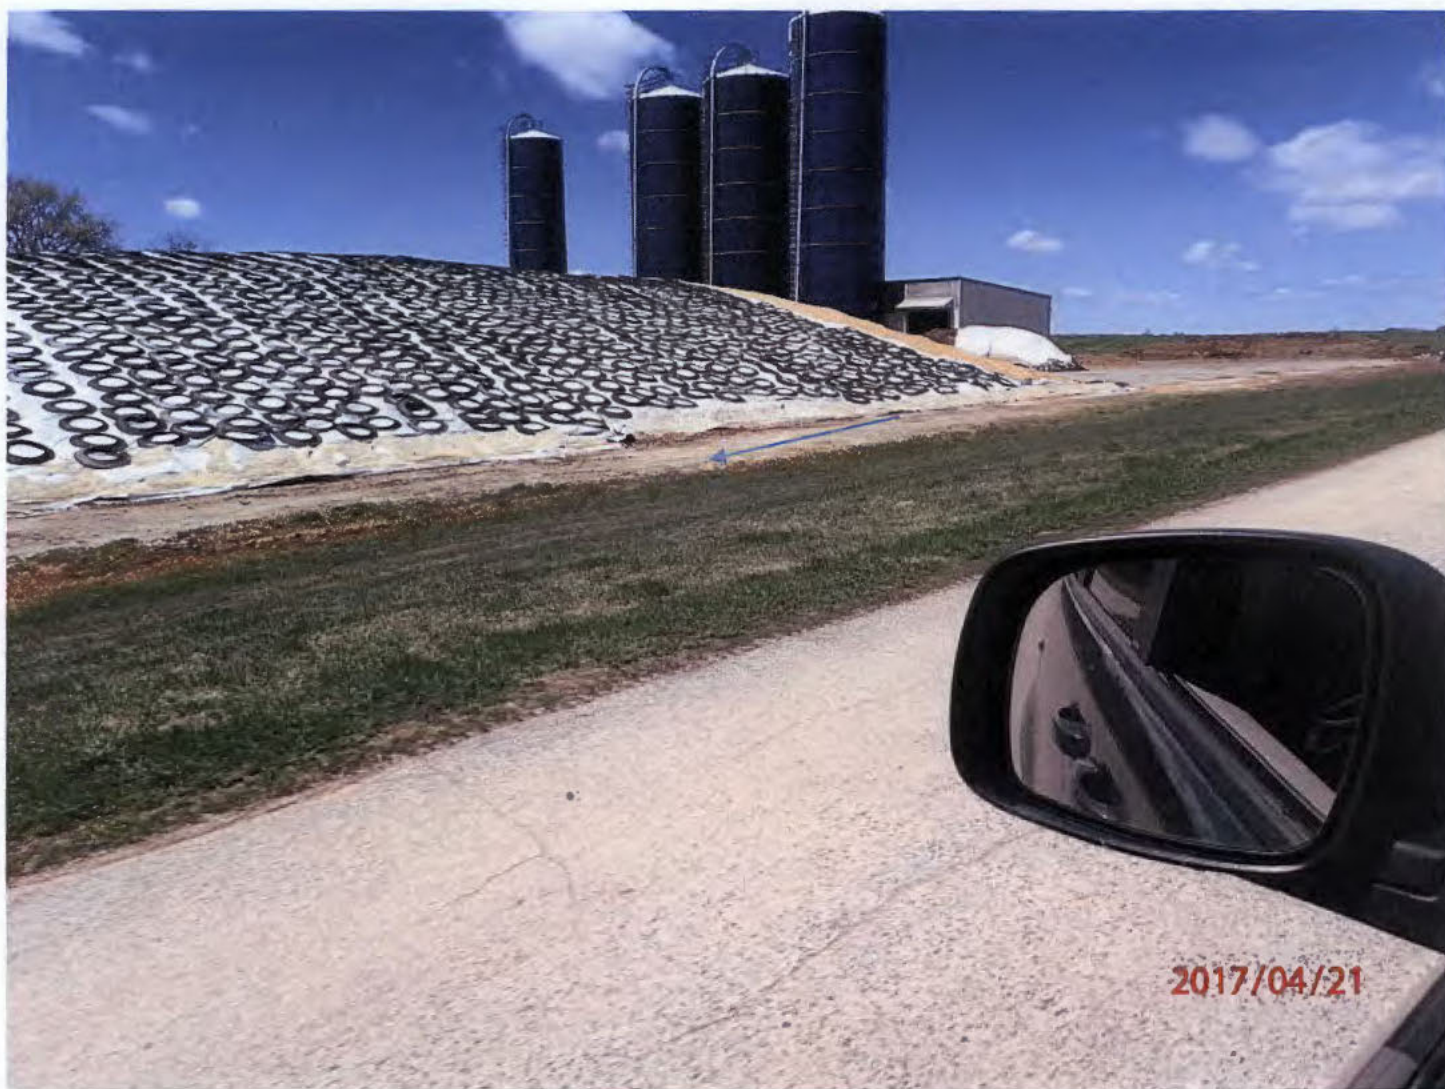
Photo: P4210101

Description: EPA observed starting at the intersection of County Road F and Lilac Lane and driving north on the Lilac Lane the terrain went uphill.

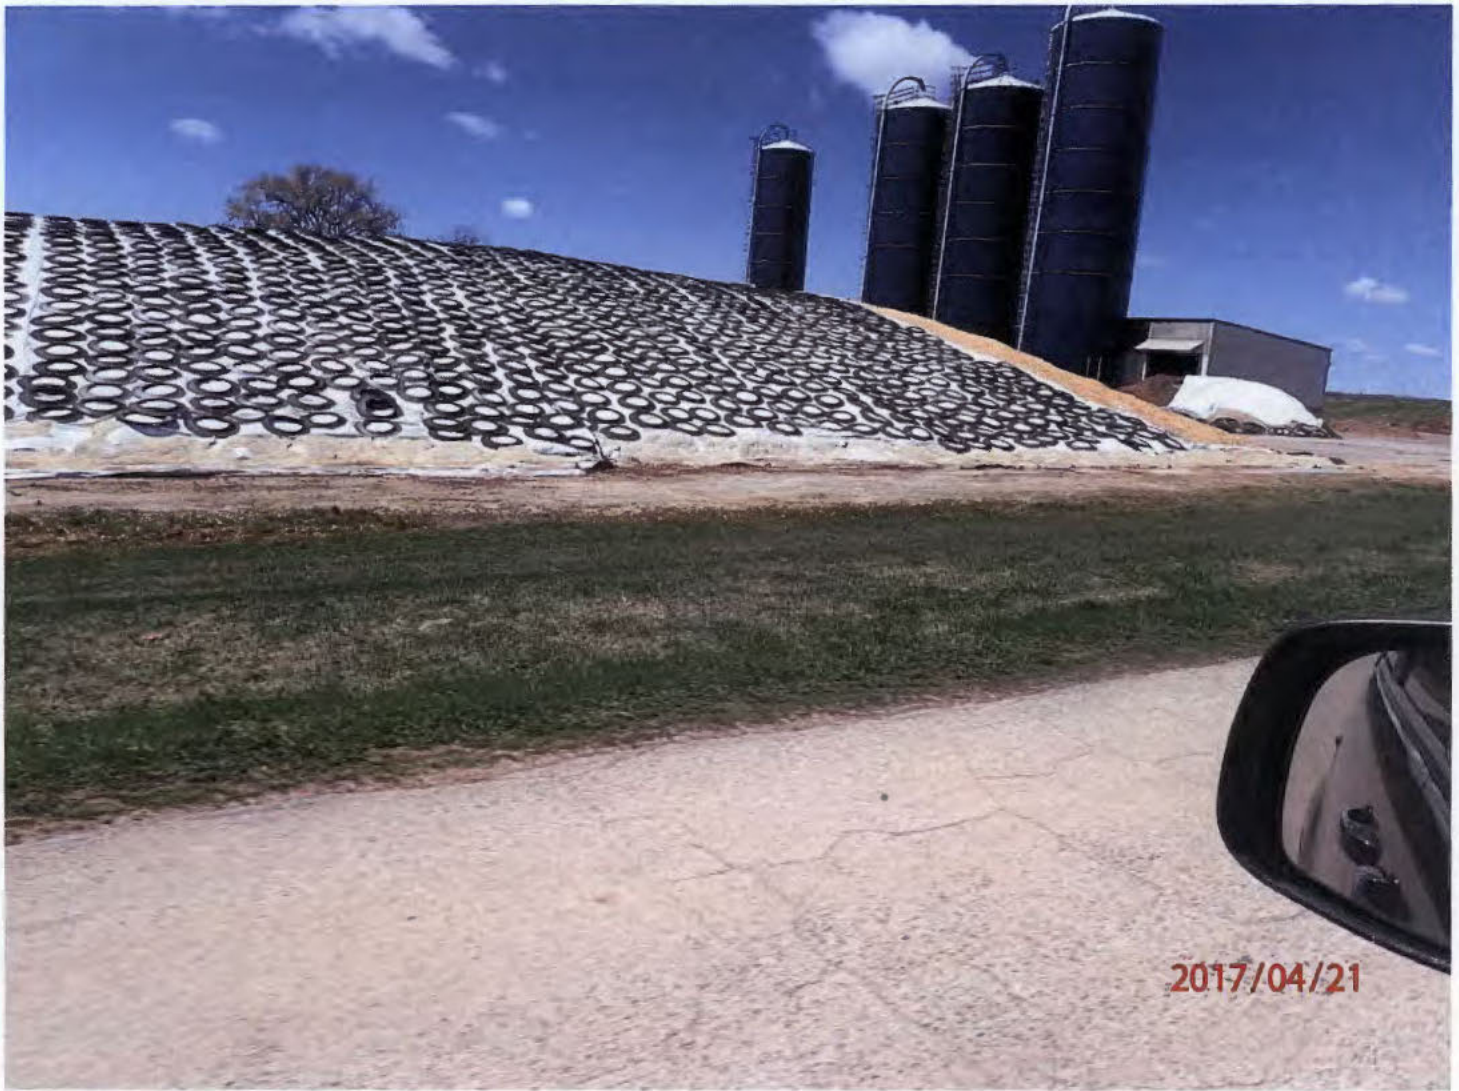
Photo: P4210102

Description: EPA observed that from the intersection of County Road F driving north on Lilac Lane the road goes uphill and the silage pad is sloped to the south.

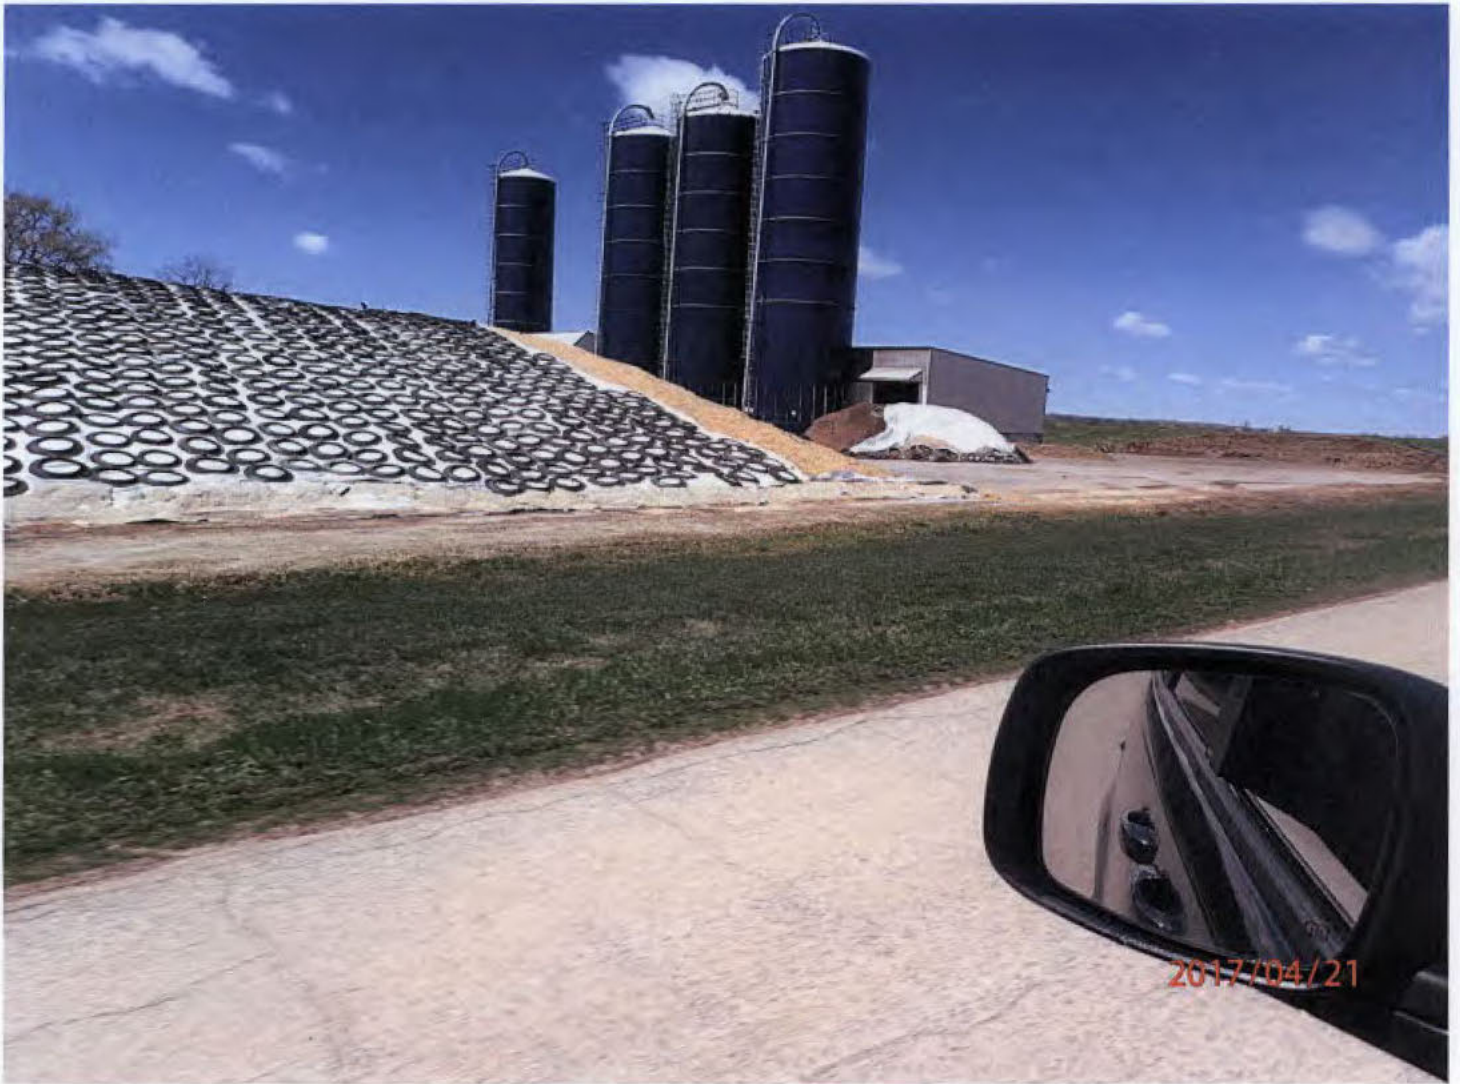
Photo: P4210103

Description: EPA observed that on the north side of the silage pad no feed or surface water was observed within the roadside ditch on west side of Lilac Lane due to the slope of the silage pad and roadside ditch to the south.

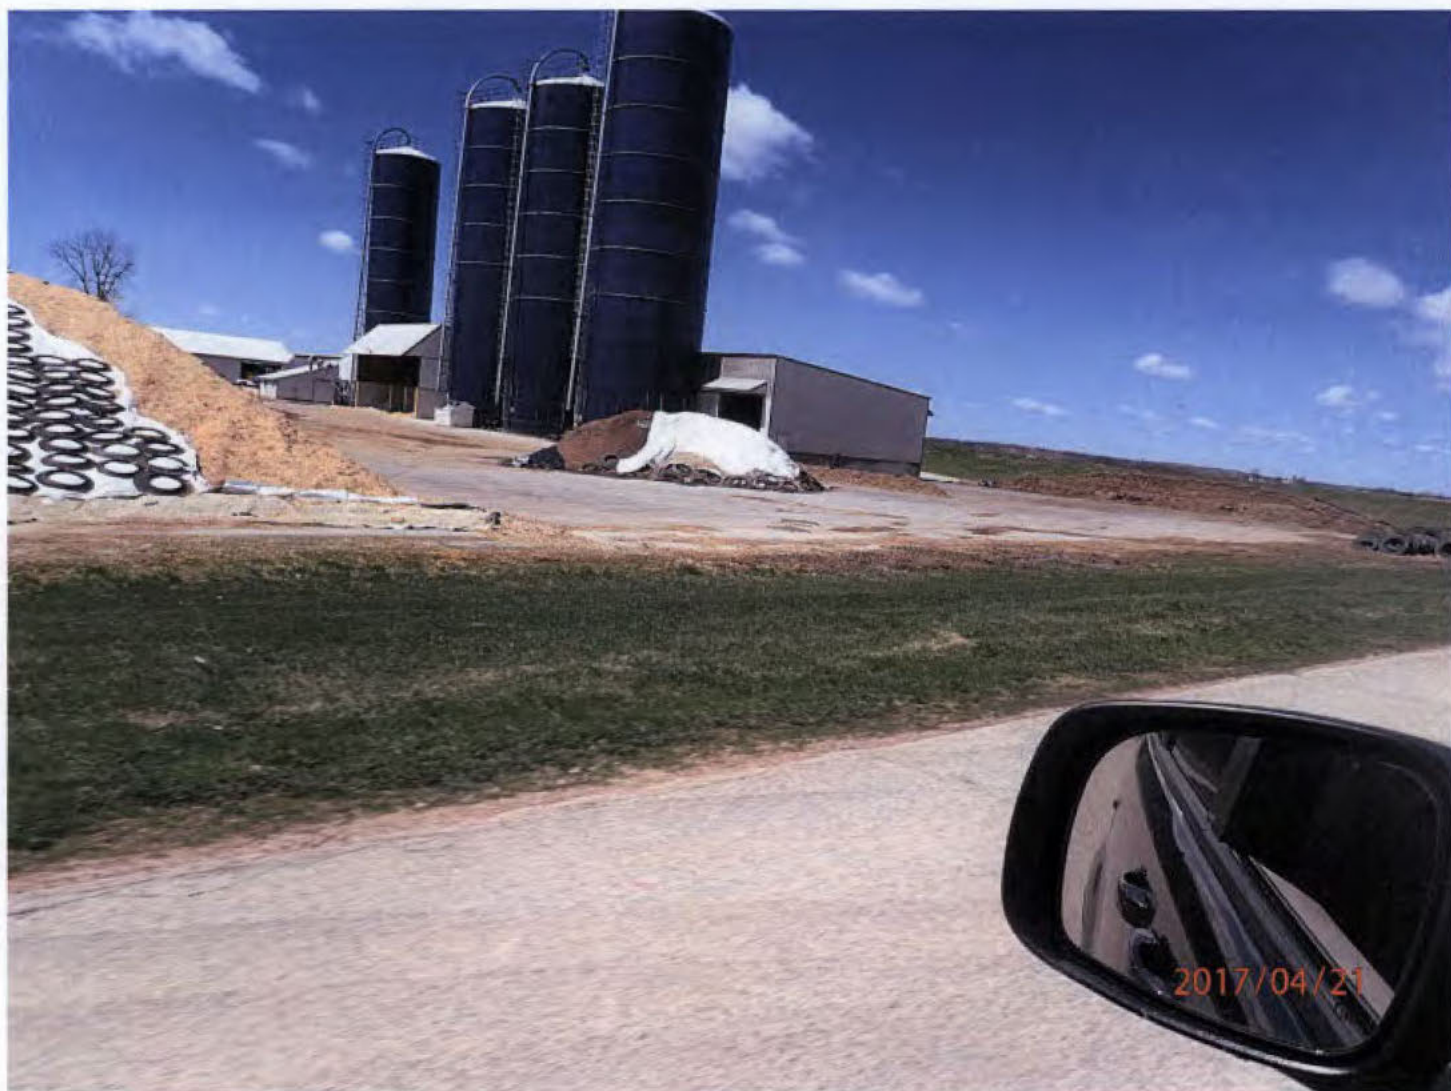
Photo: P4210104

Description: EPA did not observe any other sources, except Legend Farms Dairy, LLC discharging feed and surface water into the roadside ditch on west side of Lilac Lane due to the slope of the silage pad and slope of the roadside ditch to the south.

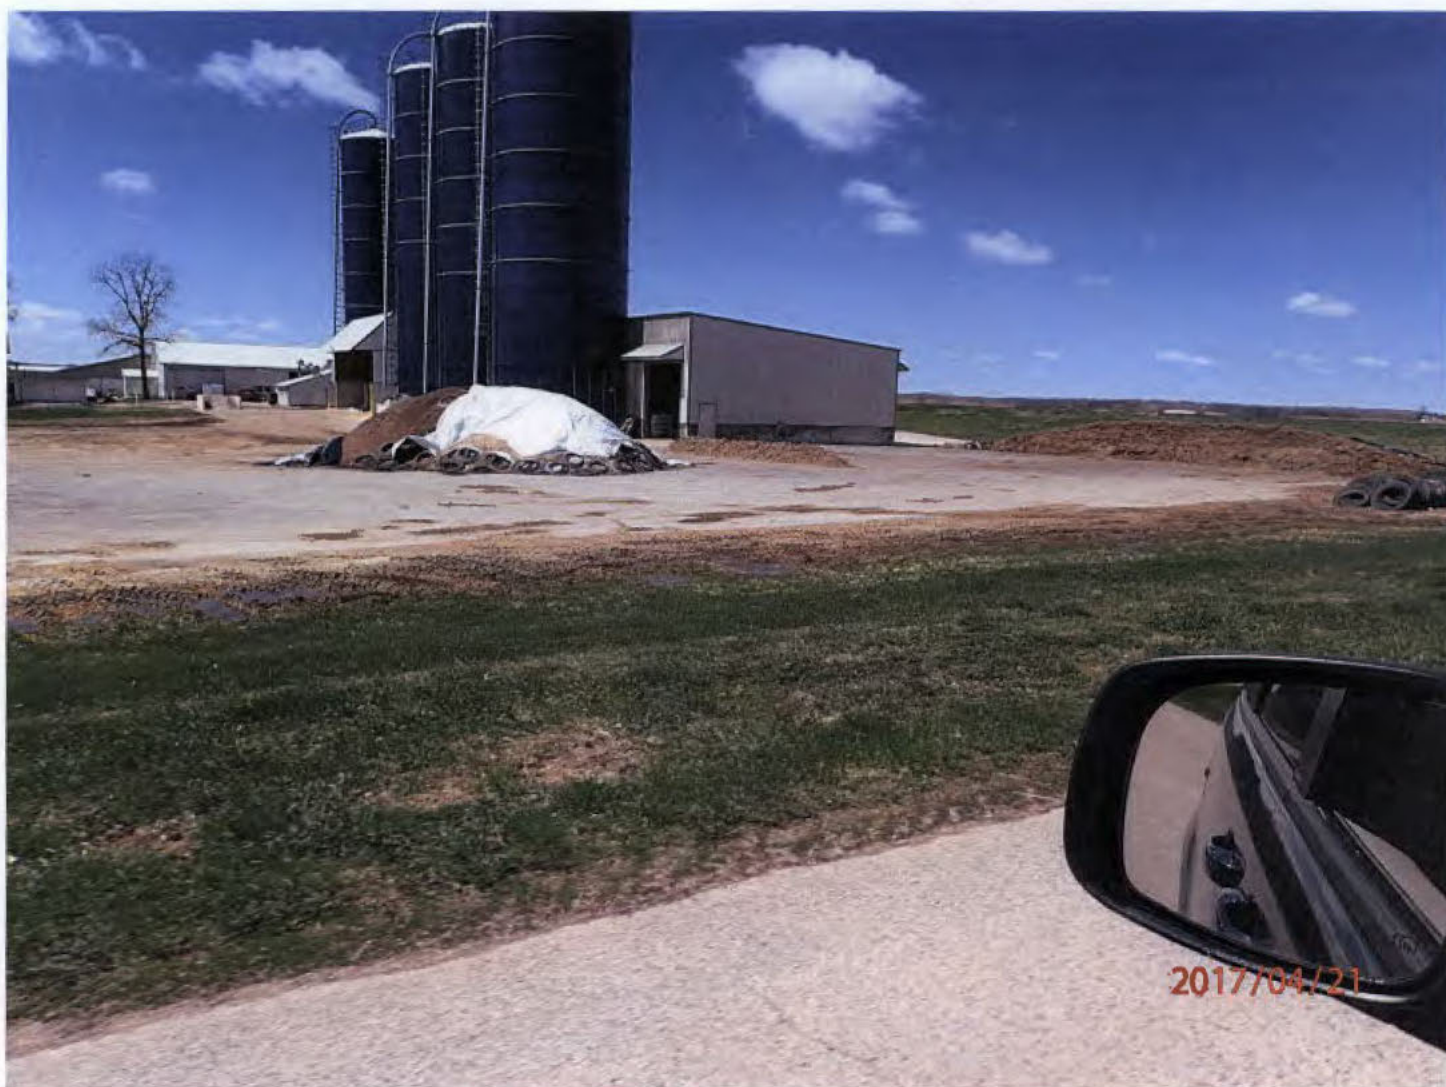
Photo: P4210104

Description: EPA did not observe any other sources, except Legend Farms Dairy, LLC discharging feed and surface water into the roadside ditch on west side of Lilac Lane due to the slope of the silage pad and slope of the roadside ditch to the south.

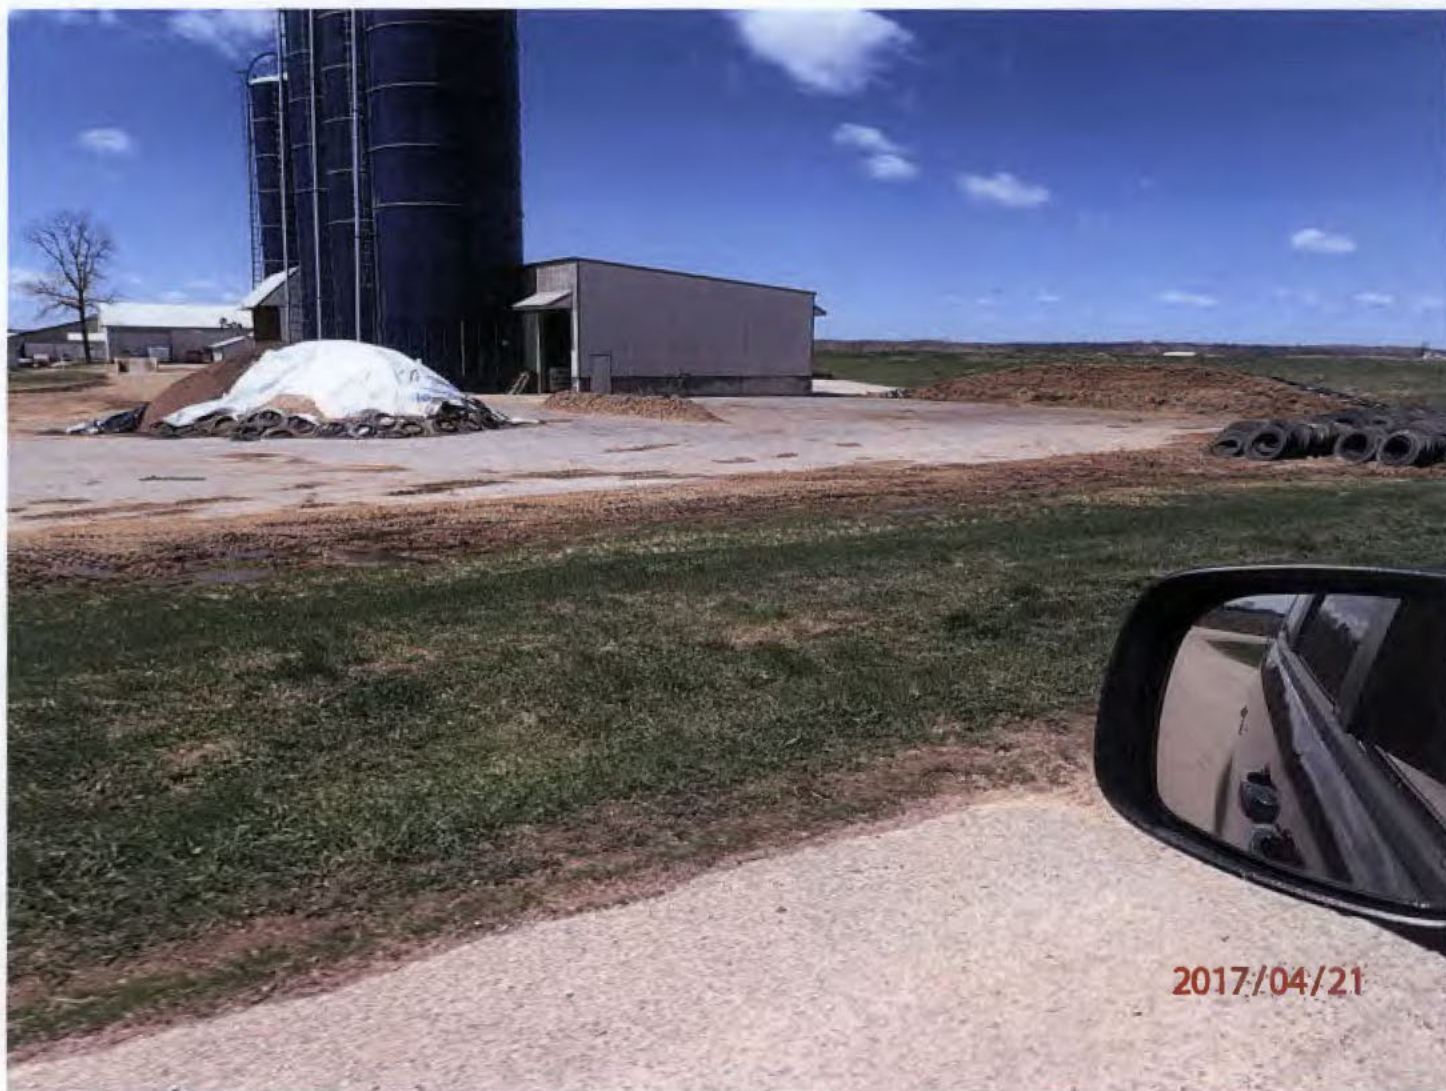
Photo: P4210105

Description: EPA did not observe any other sources, except Legend Farms Dairy, LLC discharging feed and surface water into the roadside ditch on west side of Lilac Lane due to the slope of the silage pad and slope of the roadside ditch to the south.
